enVision Power Conditioning System Solves Mysterious Digital Display Failures

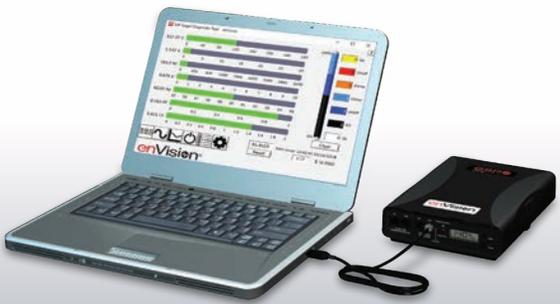
Identify and troubleshoot power-related problems

At this point, Komendera used the enVision unit to measure the line voltage and made an illuminating discovery; a constant 17 volts flowing unchecked from neutral to ground. He then confirmed this reading with a voltage meter. Once the issue had been identified he suggested the AVAD team bring an electrician down to investigate further. During the initial phone conversation the electrician suspected that the feedback voltage was likely being caused by a faulty device on the circuit. After subsequent testing at the line, panel, and transformer it was the electrician’s turn to make an illuminating discovery. Seeing no issues from faulty devices he ultimately called the manufacturer of the building’s 15 year-old transformer and determined by the model/serial number that the unit was not bonded at the factory. This simple but critical step can cause serious power issues when not performed correctly. The electrician picked up \$6 worth of parts, bonded the unit to the ground, and instantly solved the feedback voltage issue.

The electrician picked up \$6 worth of parts, bonded the unit to the ground, and instantly solved the feedback voltage issue.
